Architecture Constructions Which Were Established Taraklı In Sakarya, Turkey

Abstract: Taraklı, although its history goes very back, is an Ottoman settlement place in which the Ottoman civilian architecture samples are abundant when its pattern that should be protected was taken into account. It is a fact that the mentioned architectural asset was unnoticed until the recently and the required studies should be carried out in order to reveal this our valuable heritage. It is an expected process for this 200-300-year architectural pattern to fray and extinct. It is only possible with the academic studies to stop or slow down this process. The value of the studies on this issue was stated in traditional architectural heritage regulation as follows. “Traditional architecture has a special place for the whole society and it is a reasonable source of proud. It is accepted as an attractive product that reflects the characteristics and differences of the society. It is utilitarian, attractive and pretty. It is both the focus of contemporary life and a document for the past of a society. It is an inappropriate behavior not to make an effort to maintain these traditional harmonies which cre

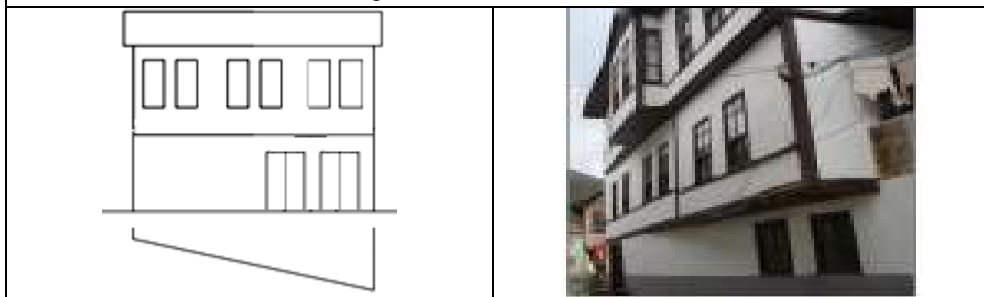
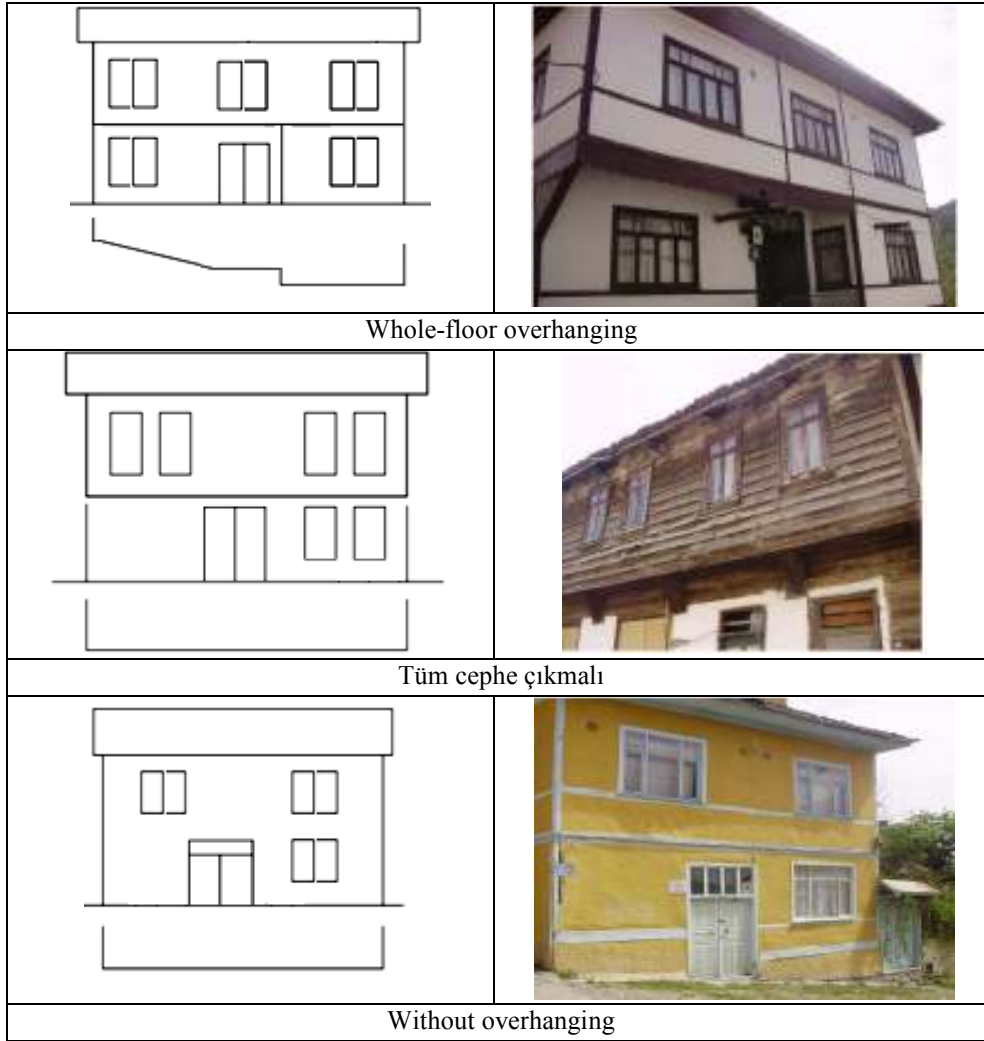
Figure 5: Front Views and Building Typologies

At the end of the typological research, the traditional architectural plan type was determined. At the end of this study, it was found that the buildings in Taraklı were with overhanging in the middle, overhanging in lateral, double overhanging, a rooftop terrace with an extensive view, one-saw overhanging, saw-overhanging, whole-floor overhanging and without overhanging. There are many buildings in Taraklı with the aforementioned typological characteristics and with different appearances. The structures below are examples of these typological characteristics. These examples are presented figuratively and visually below (Figure 5)

Overhanging in lateral

Double overhanging

A rooftop terrace with an extensive view

One-saw overhanging

Saw-overhanging

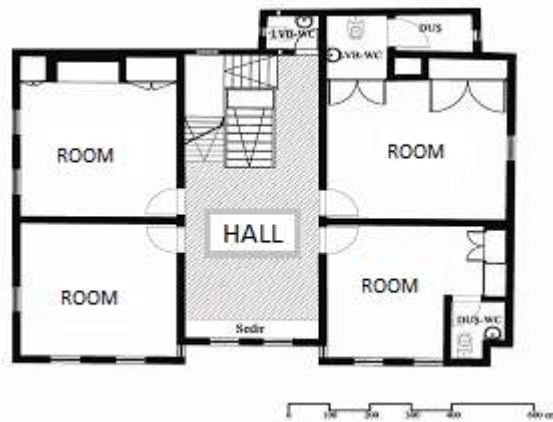
Figure 7: A Sample for Plan Style with Internal Halls

The hall is between the sequences of rooms placed in both sides of it (Figure 7). The hall is enriched with the elements like iwan, stair hall and overhanging. In some samples, hall is reflected on the front with different types of windows according to the rooms.

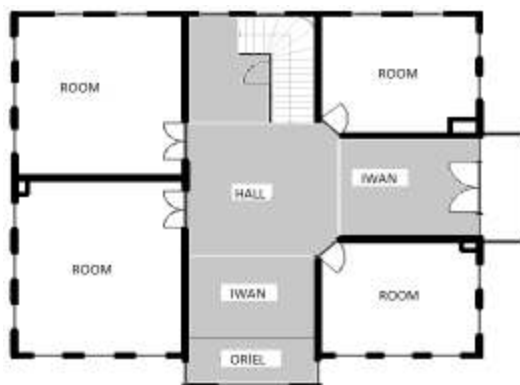
Figure 8: A Sample for the Plan Style with Halls in the Middle

In the light of the principles of the plan style with halls in the middle schema, a plan type that is composed of a hall in the middle and rooms in both sides and known also as split aubergine model can be seen (Figure 8). Although the external hall is unprotected against the harsh climate, the hall in this type of plan is protected due to the rooms. The middle hall that organizes this schema is service settings like rooms, kitchen and toilet that opened into the hall. The basement floor is connected through the entrance door and it is composed of barn, hay-barn and storage places that are opened to it.

The hall is an organizer in both floors. With a bay-window by a room attached to the hall upstairs, it enables the social interaction with the environment and the integration with the nature being oriented to the garden and yard. In the samples in Taraklı, the ceiling of the hall is higher compared to the room and big iwan's and the

embroidery is done to the horizontal strip occurred as a result of the rise. In the four-iwaned styles, the entrance of the rooms is made as chamfered and this gives an octagon appearance to the hall which is not ordered. The hall is reflected on the front with different types of windows and overhanging.
